historic structure report  
architectural data section  
volume 1  
june 1985

HISTORIC STRUCTURE REPORT

Architectural Data Section

LINDENWALD

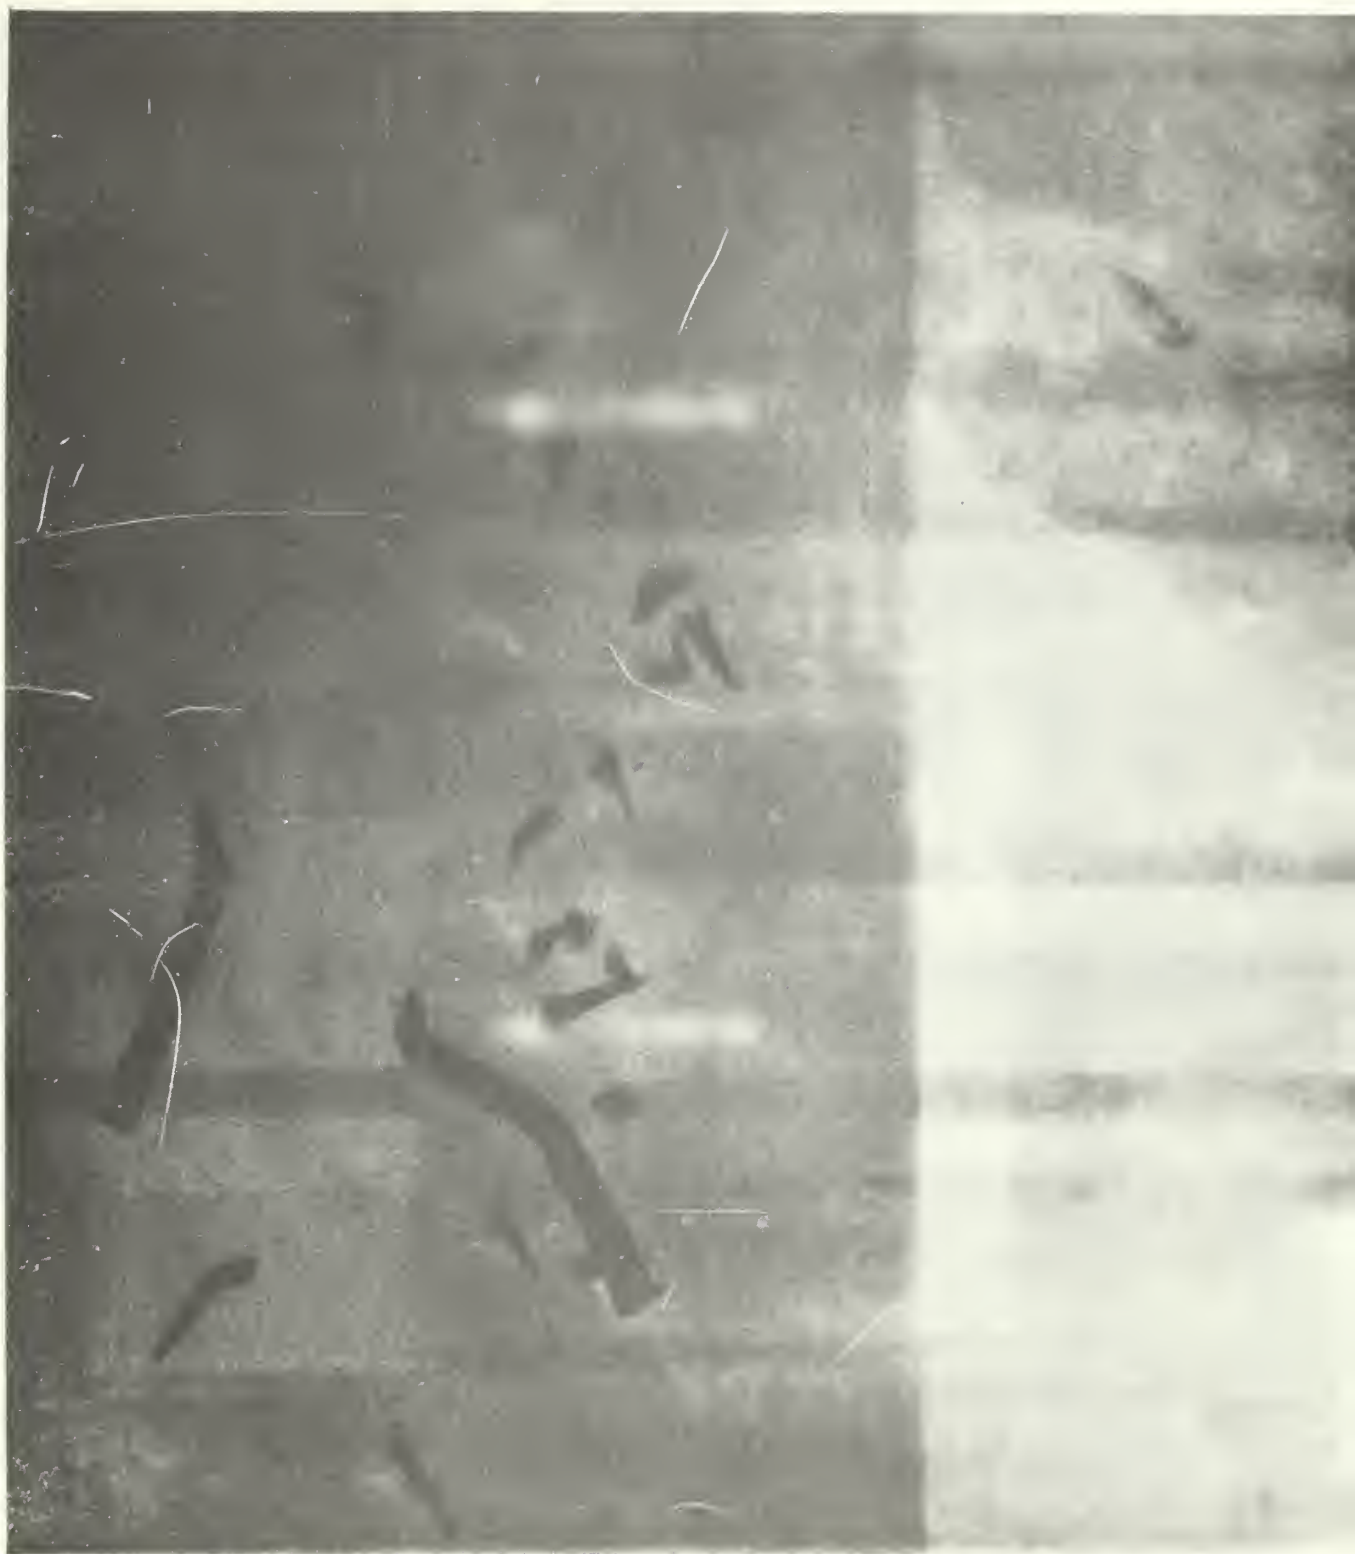
MAVA 01 X013

Room 208, north wall, ghost of door opening, looking north 2'10" above the floor.

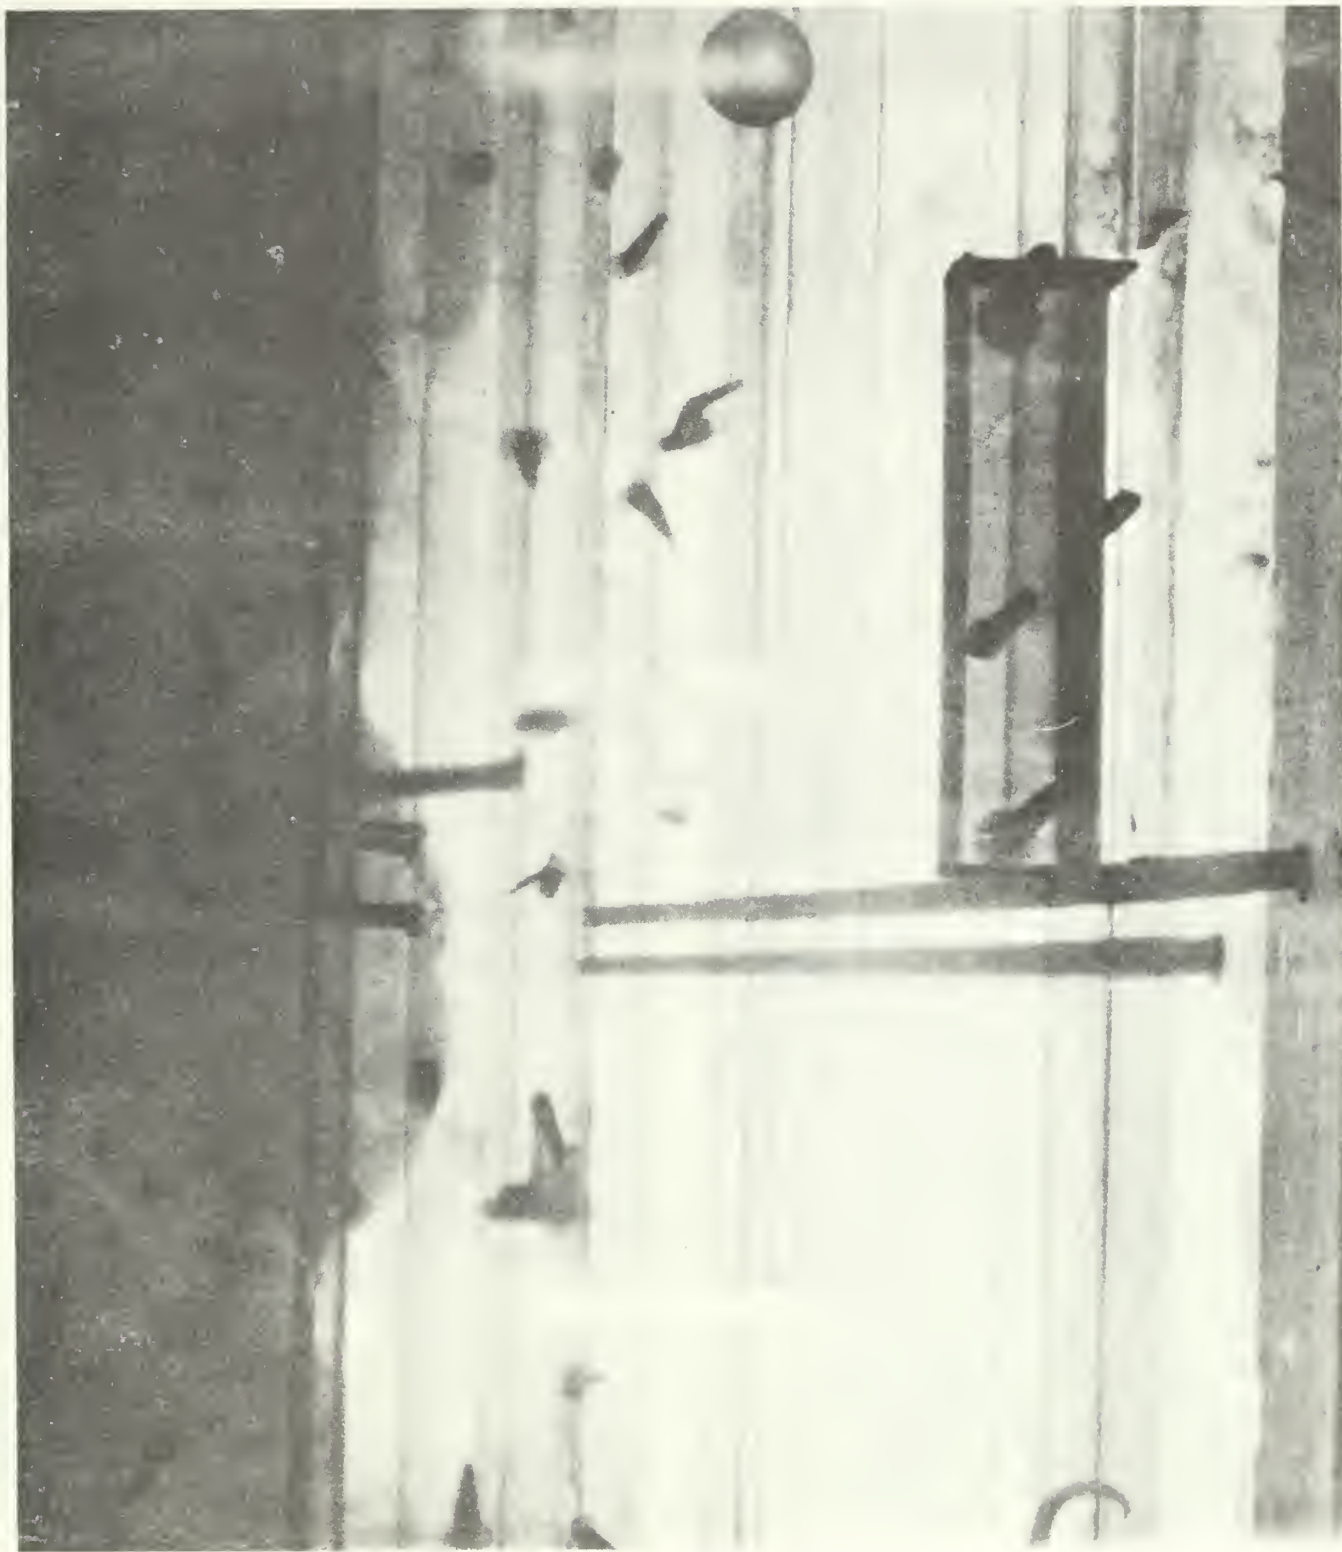
MAVA 01 X015

Room 208, north wall, door 203, west jamb, looking north 2'10" above the floor.

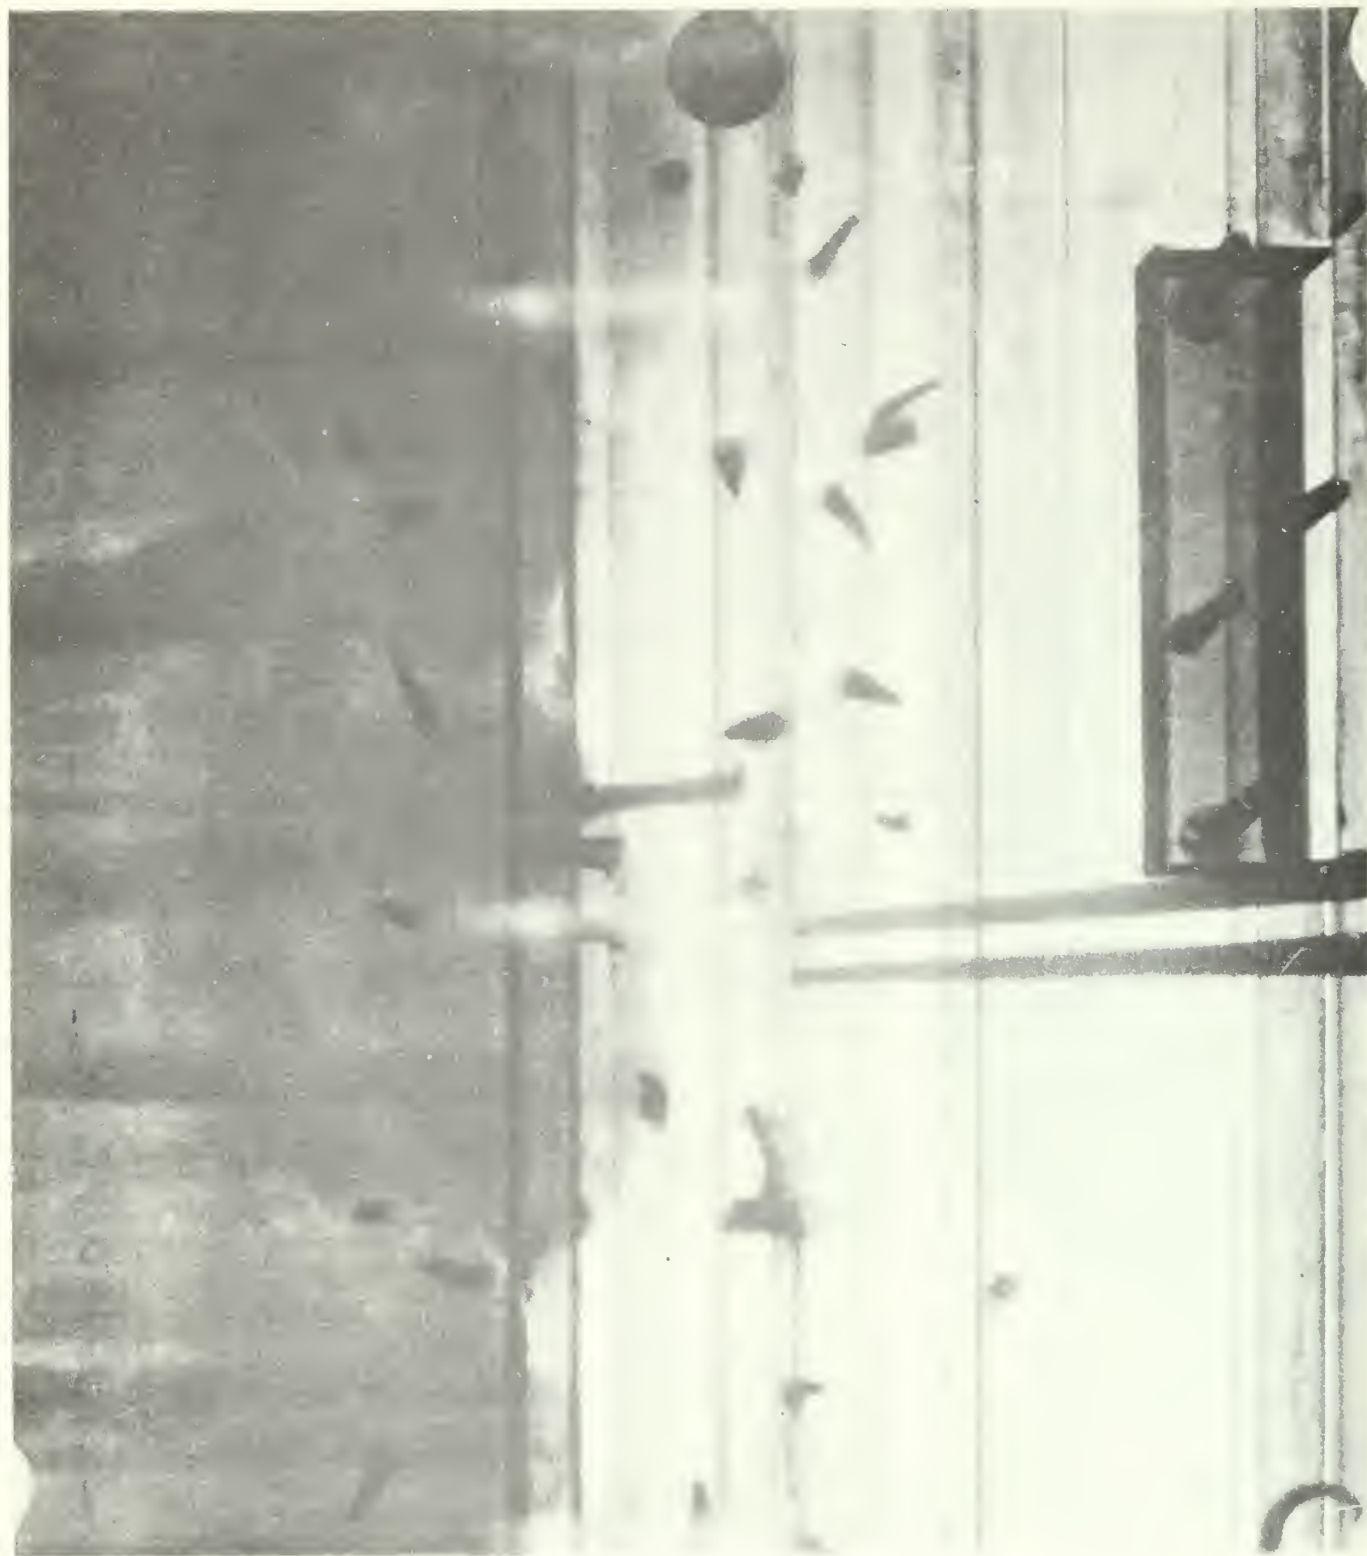
MAVA 01 X106

Room 208, north wall, door 203, west jamb, looking north 2'10" above the floor.

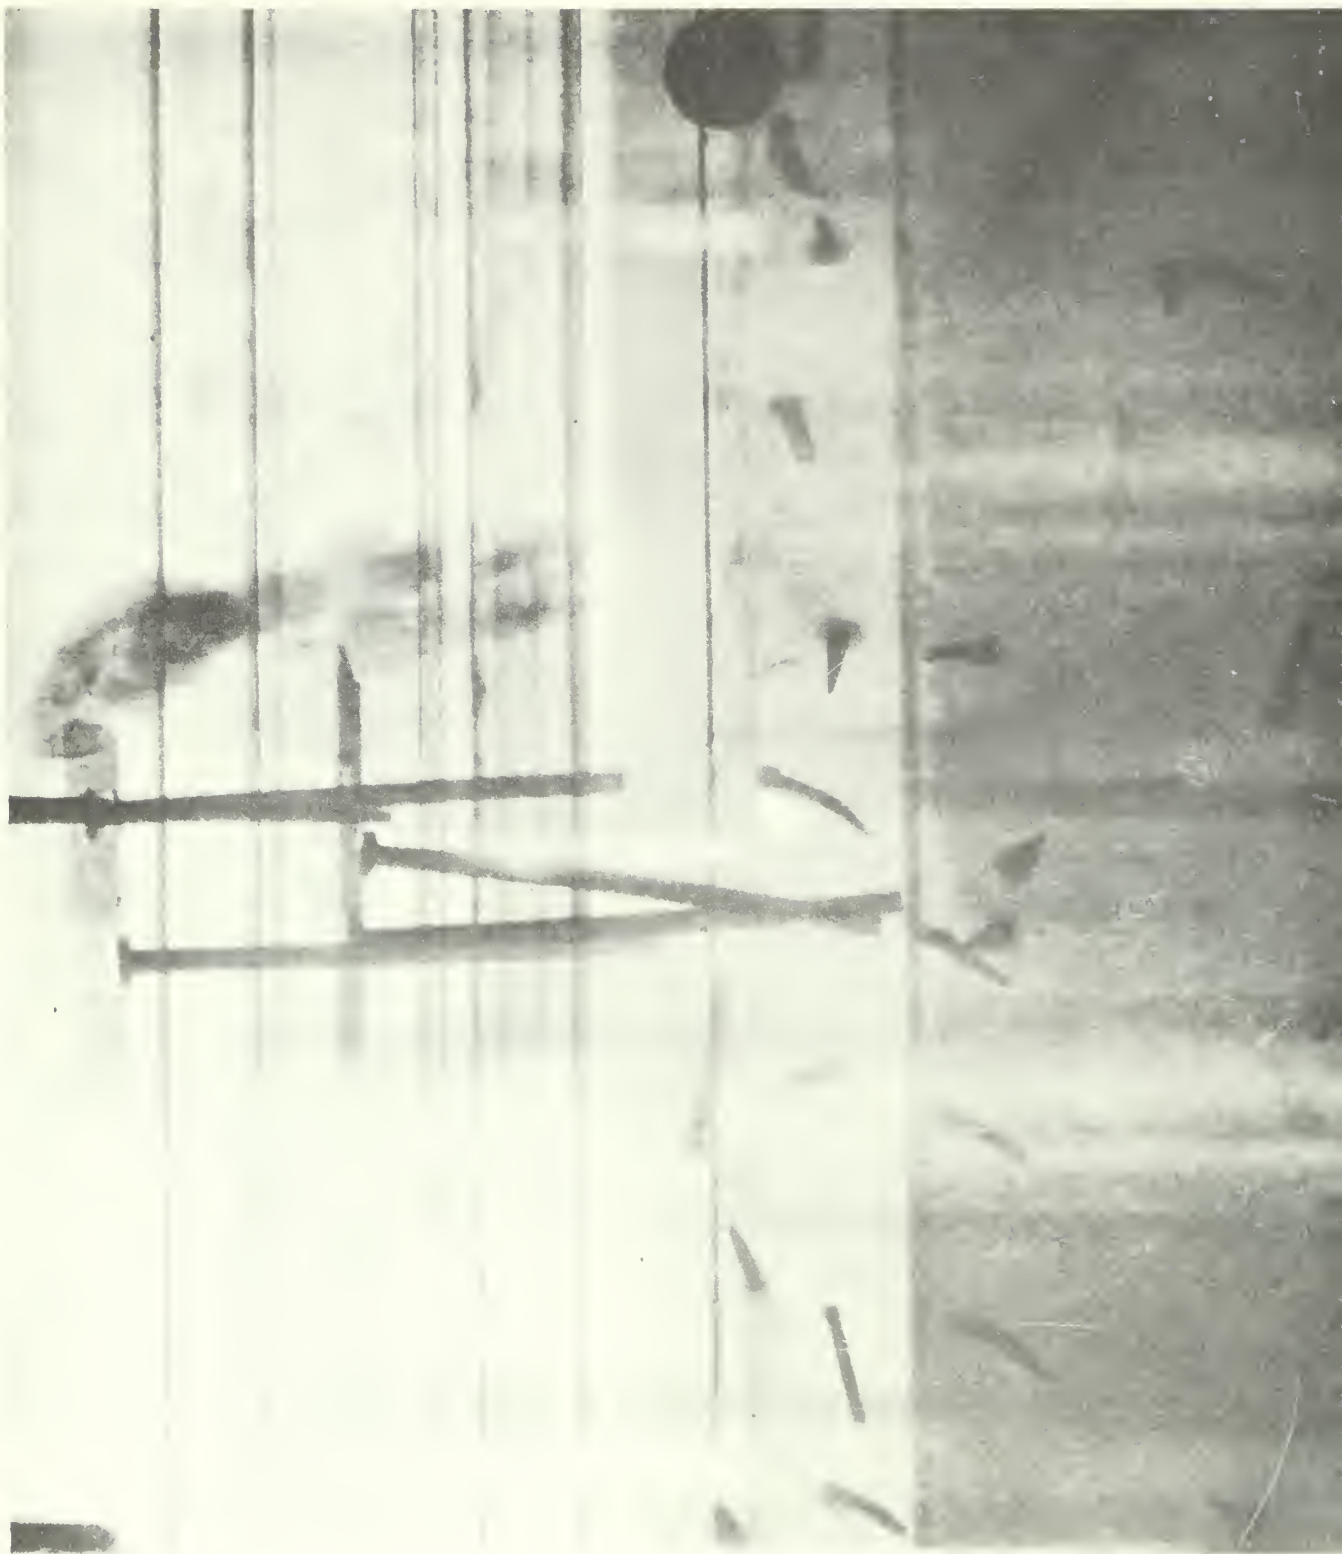
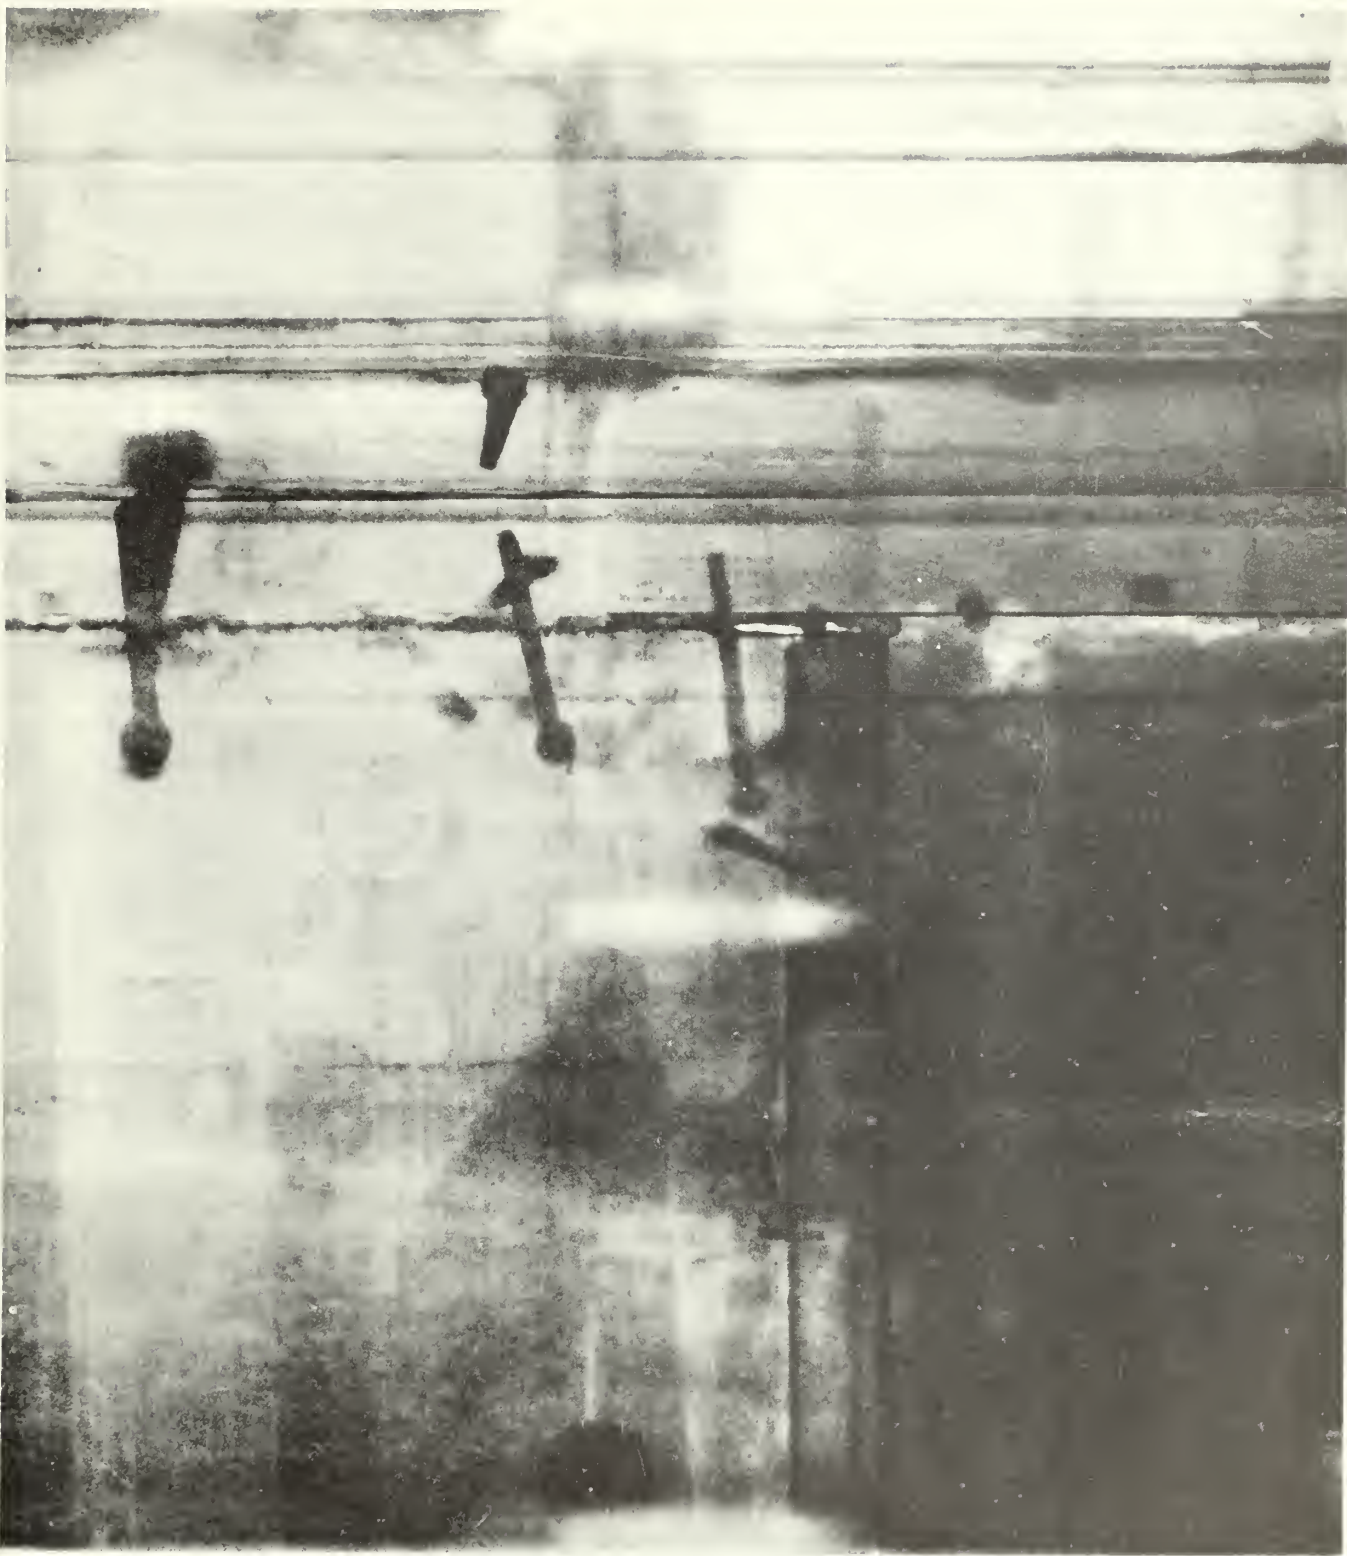
MAVA 01 X018

The X-ray taken at the floor level shows the wood pin securing a stud tenon to the plate. This information supports the existing physical evidence of change in the location of the door opening (see MAVA 01 X018-019).
